Water Compliance Inspection Report

Water/NPDES Compliance Inspection, NPDES No. DC0000019

Department of the Army, Baltimore District, Corps of Engineers, Washington Aqueduct Division Washington, DC.

Inspection Date: May 30, 2012

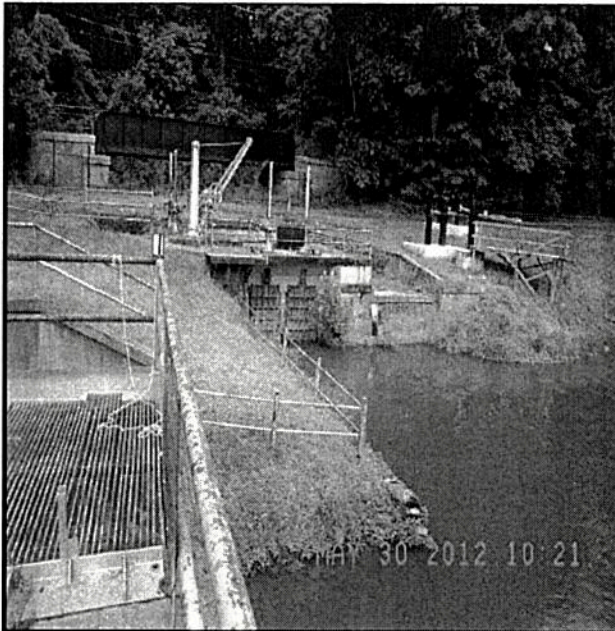
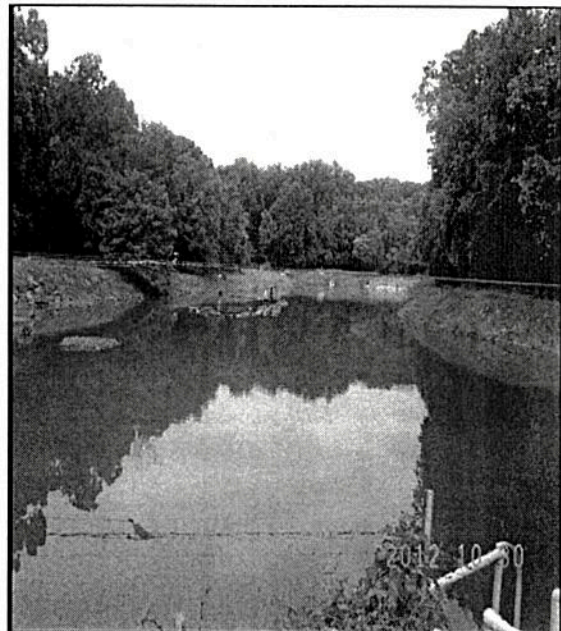
Photo #2: Intake structures at the Forebay Reservoir (left). Raw water from Great Falls on the Potomac River flows under gravity into the Forebay Reservoir (right).

Under normal operating conditions, raw water is diverted from the Potomac River at (i) Great Falls dam, Maryland and piped to the Forebay Reservoir (**Photo #2 & 3**) and then onto the Dalecarlia Reservoir (**Photo #4**). During low flow conditions in the Potomac River, raw water is drawn from the Little Falls dam (**Photo #1**) and piped to the Dalecarlia Reservoir through the Forebay Reservoir. At either treatment plant, raw water is subjected to a full conventional treatment process (shown in **Figure #3**) to remove suspended solids, sediments, bacteria, and microorganisms to produce drinking water.

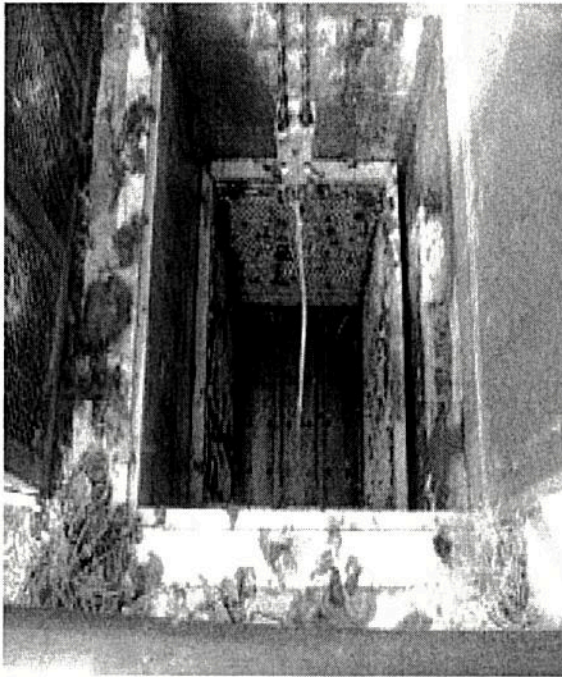
Photo #5: Screens for removing debris, trash and litter at Dalecarlia Reservoir pumping station.

(i) **Screening:** Raw water is passed through a series of screens designed to remove debris such as twigs and leaves (**Photo #5**) prior to pre-sedimentation and other treatment processes within the plant (**Photo #6**).

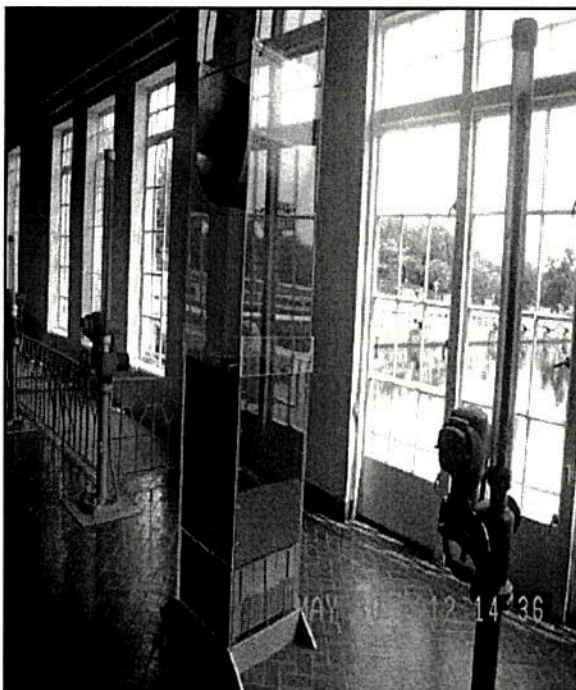
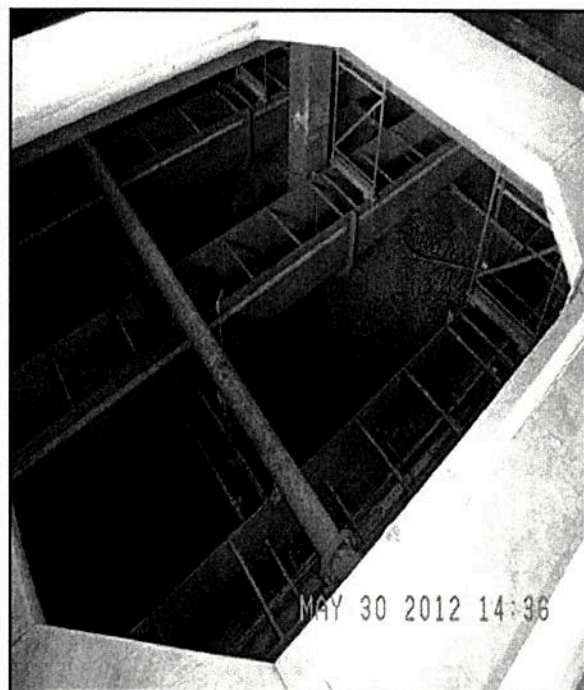
Photo #8(a): A model of rapid gravity sand filter. **Photo #8(b):** Empty rapid gravity sand filter.

(vi) **Filtration:** Supernatant in the sedimentation basins decants into gravity filter media units consisting of layers of granular anthracite coal, sand, and gravel (**Photo #8**). Filtered water passes through to a collection system underneath.

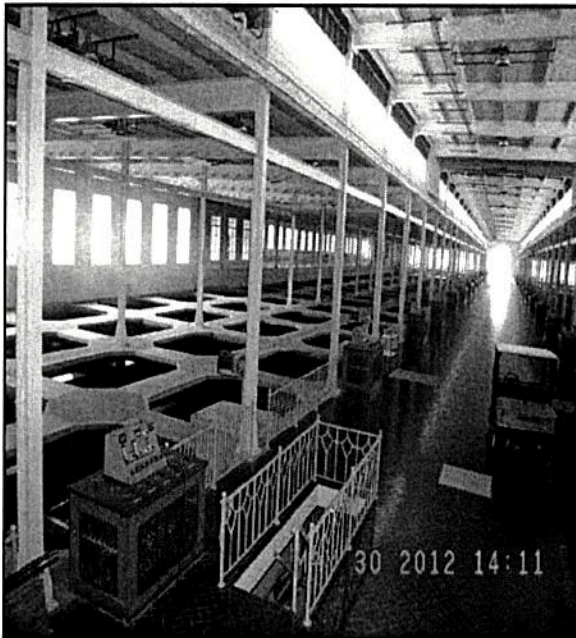
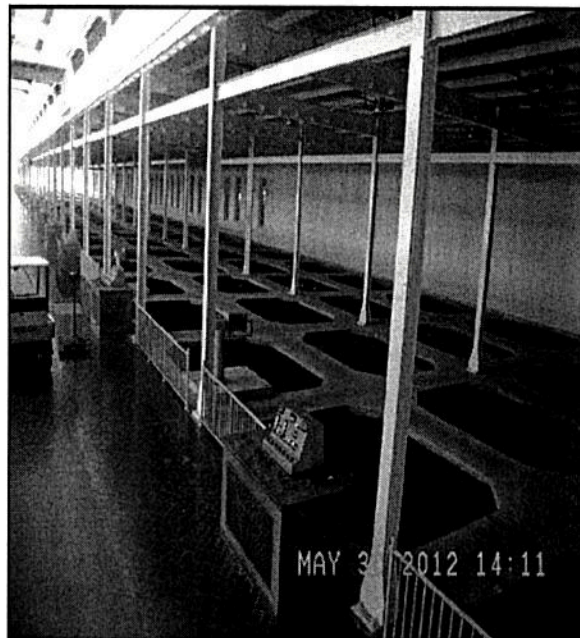
Photo #8(c): Rapid gravity sand filters in the filtration room.

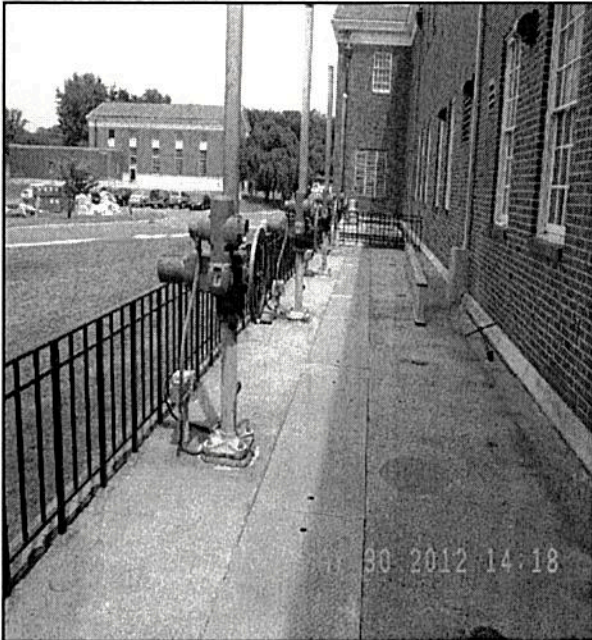
Photo #11: Flow gates to the Dalecarlia sedimentation basins.

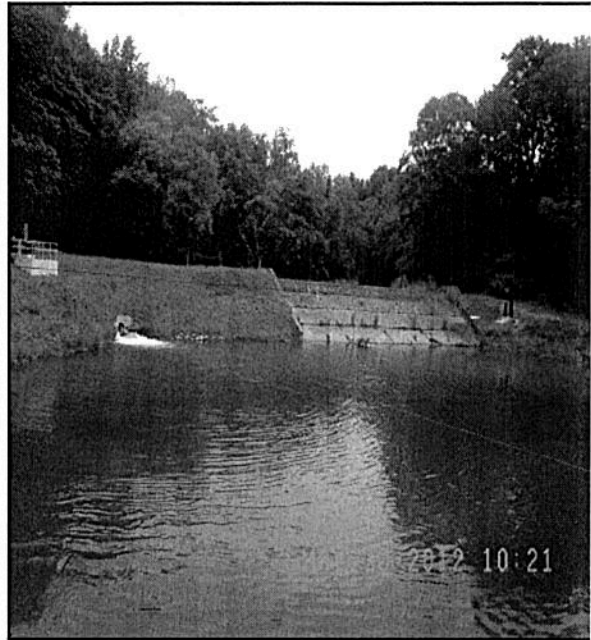
Photo #12: Filter backwash water is returned to the Forebay Reservoir.

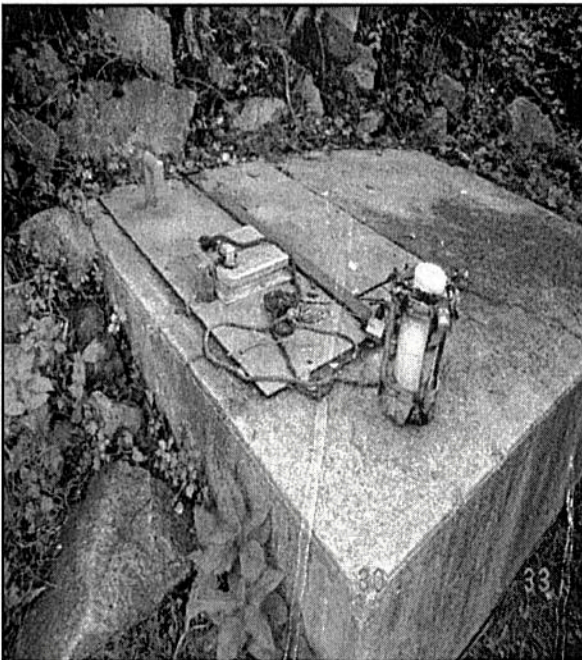
Photo #13: Outfall 002Q – sampling equipment (left) and water continuously flowing from Outfall 002Q (right).

The permit was available for review at the facility and was satisfactory. The facility representatives indicated that since the RPF begun operating, there will be no discharge from the basins, apart from basin leakage and groundwater seepage through Outfall 002Q (**Photo #13**).

Review of the discharge data from Outfall 002Q between February and May 2012 found that the facility was in compliance with Permit limits. At the time of inspection, discharge from Outfall 002Q was relatively clear (**Photo #13**), and had no foaming on contact with the flowing receiving water body (**Photo #17**).

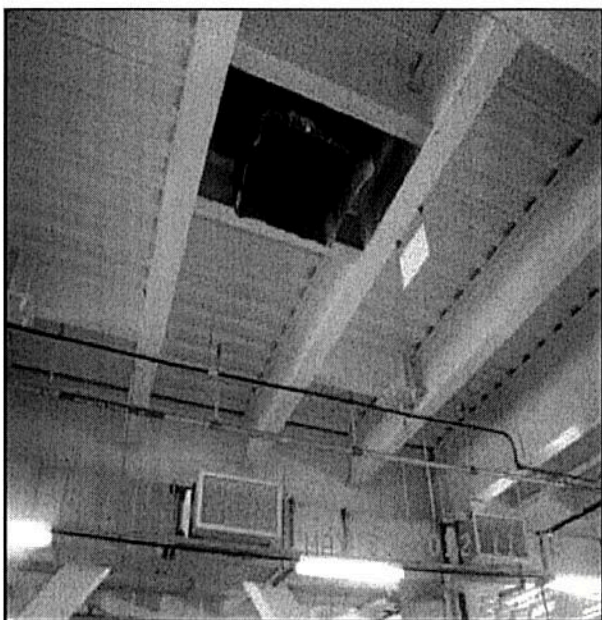
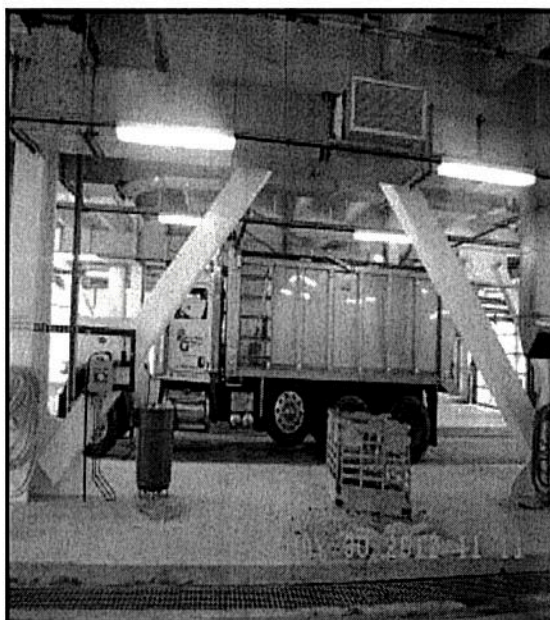
Photo #15: Left - treated residue chute from the chamber bins and right - treated residues are loaded in a truck.

The treated residues are loaded into trucks and taken offsite by a contractor for composting and land application (**Photos #15 & 16**).

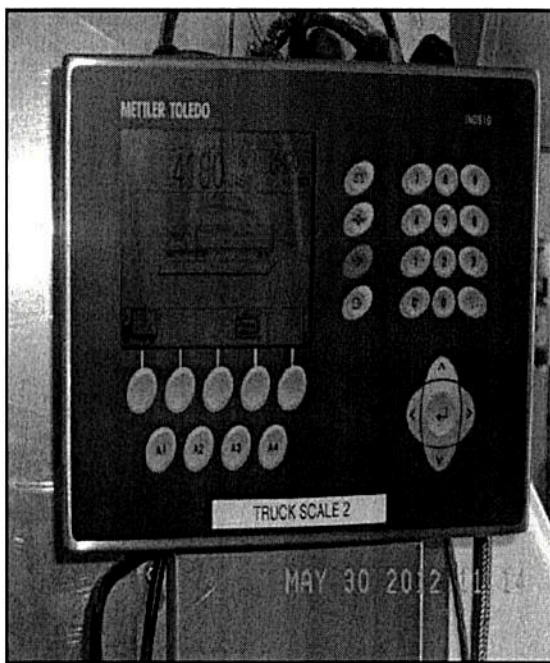
Photo #16(b): Treated residues are weighed before being trucked offsite for disposal.

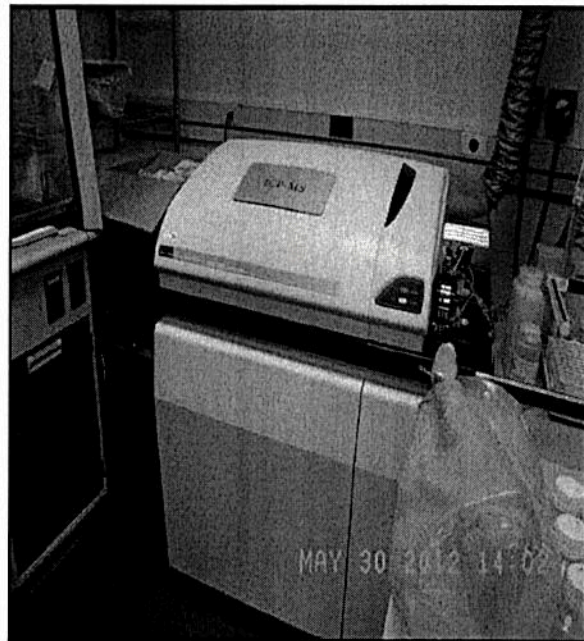
Photo #18: Laboratory equipment.

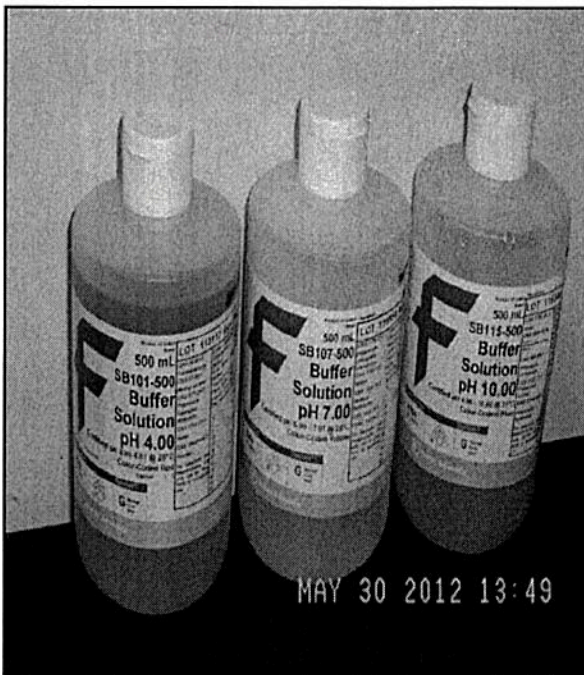
Photo #20: Laboratory chemicals or pH buffer solutions.
